Manhole Inspection Summary

Manhole # S15GG1002MH

Insp Date: **3/1/07 10:47 AM**

Location Address: **2508 LOYOLA SOUTHWAY**

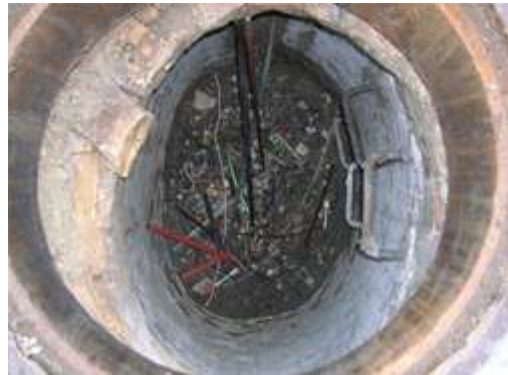
Top View

Channel debris.

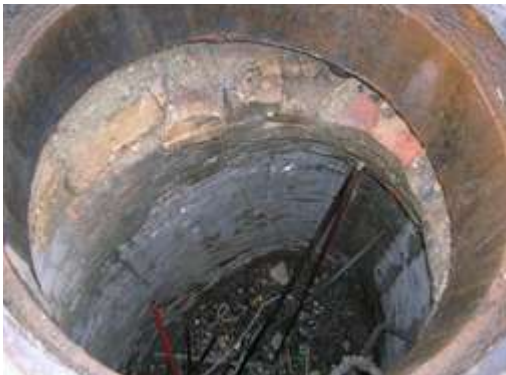
Defect

Frame leaks. Adjustment loose bricks and deterioration, Adjustment and Corbel infiltration, bench debris

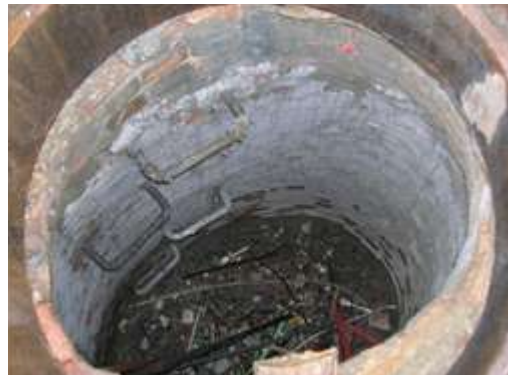
Defect

Frame offset. Adjustment loose brick, deterioration, and infiltration. Corbel and Barrel infiltration. Channel debris.

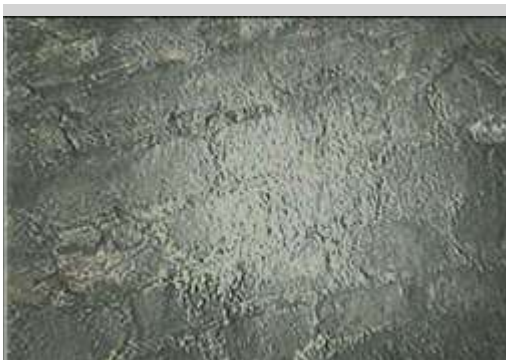
Defect

Barrel infiltration.

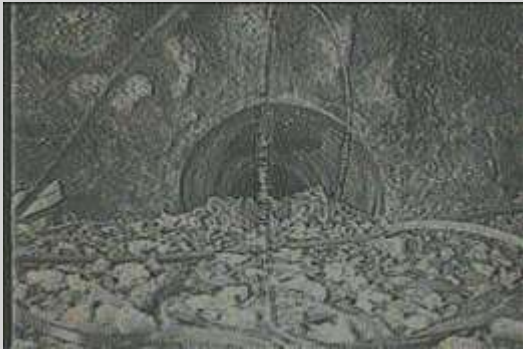
8 in. Circular Gravity Sewer
Pipe Out @ 12 O'Clock

Barrel deterioration.
